Monitoring Data Record

Project Title: R-2552B Clayton Bypass COE Action ID: 200220745

Stream Name: Site 5 DWQ Number: 041760

City, County and other Location Information: US 70 Clayton Bypass from I-40 to US 70

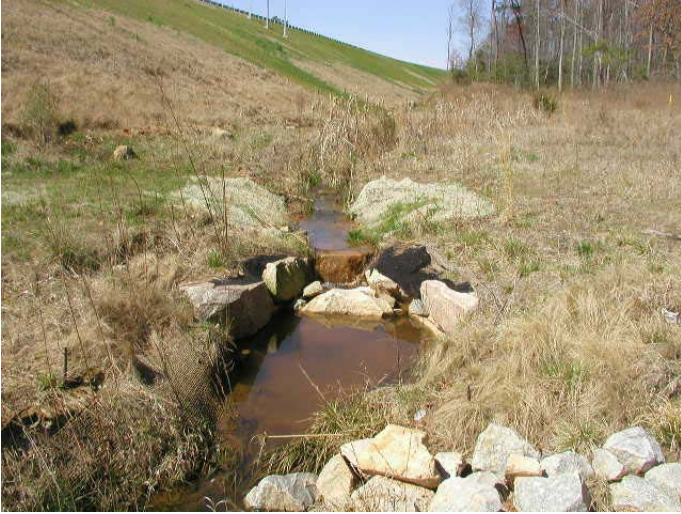
Photo Point #4 (Upstream)

The stream relocation is stabilized for the Year 2 winter evaluation. The second cross vane upstream (Photo Point #4 Upstream) from the box culvert that was noted last monitoring evaluation with a slight headcut and water piping under the crossvane has been repaired. The left bank below the repaired crossvane developed two areas where some bank erosion had taken place since our last monitoring evaluation. It was decided between the regulatory agencies and DOT to place riprap in these two areas to stabilize the left bank. NCDOT will continue to monitor channel stability at this stream relocation.
